MRI Laboratory Safety Manual

UCLA
Brain Mapping Center

**Ahmanson-Lovelace Brain Mapping Center
University of California, Los Angeles**

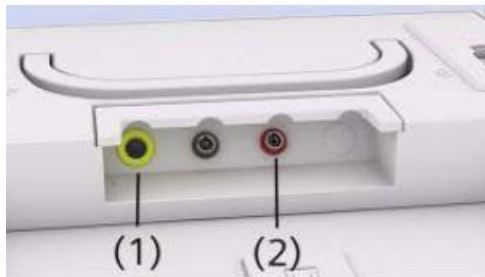
Prisma squeeze bulb connector at the foot of the bed is labeled (2) and the hose connector is red

The scanners are equipped with a squeeze bulb that allows the participant to set off an audible alarm to attract the operator’s attention. The squeeze bulb should be made available to participants unless some alternative method of constant monitoring (e.g., another person in the scanner room) is in effect. Use of the squeeze bulb or some comparable form of continuous participant monitoring is mandatory if you are operating the scanner in “Level 1” mode, which has an increased risk of magnetostimulation or participant heating due to RF energy deposition or if you are scanning a participant who has a tattoo or permanent eyeliner. The squeeze bulb plugs into the red connector at the foot of the bed. If the participant squeezes the squeeze bulb, a continuous audible alarm is emitted via the intercom and the intercom alarm button lights up.

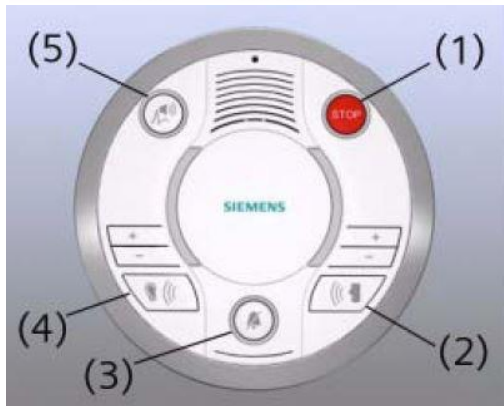
- The “STOP” button is labeled (1)
- The talk button is labeled (2)
- The reset patient alert button is labeled (3)

3. For the Siemens system, press the patient alert button (#3)
4. While holding down on the appropriate intercom talk button, speak to the participant to determine why the squeeze bulb was pressed. **Make sure that the volume is turned up so that you can hear the participant's response.**
5. If necessary, enter the room to further investigate and/or correct the problem.

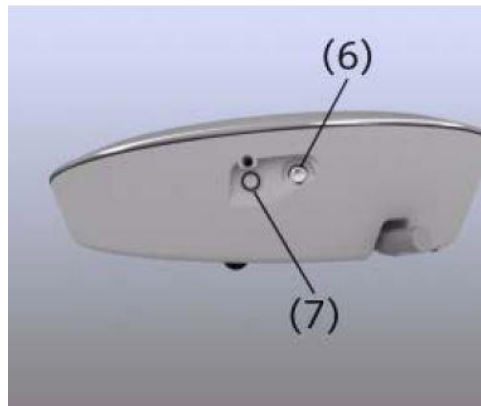
The reset table stop button is labeled (7)

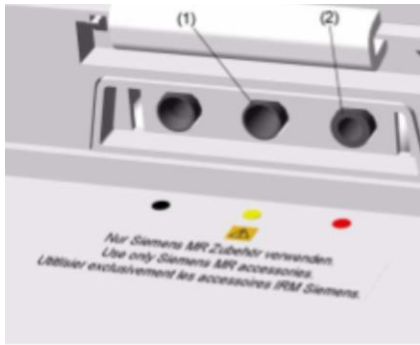
mMR squeeze bulb connector at the foot of the bed is labeled “(2)” and the hose connector is red.

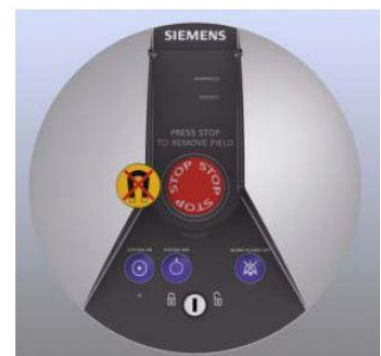
1. At the bottom of the console Home screen click the power button and then choose “Shut Down System”
2. It will take approximately 5 minutes before you the monitor and scanner room LCD turn off
3. Press the blue “system off” button on the Siemens scanner control box located on the wall next to the MR Scanner window
4. Notify ALBMC staff that you have performed a Routine Electrical shutdown. [Contact information](#) is located on the last page of this manual.
5. *If it is appropriate to restore power (wait at least 5min), press the blue “power on” button located on the Siemens control box next to the control room window. The system will need approximately 5 minutes to reinitialize. To avoid subsequent problems, make sure that the bed is*

completely out of the gantry at its home position (all the way out and all the way up) and that the top head coil is attached and plugged in or off the table before restoring power.

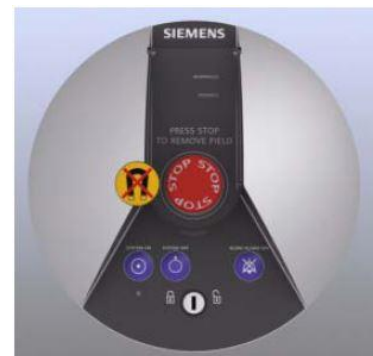
6. Press the blue “system off” button on the Siemens scanner control box located on the wall next to the MR Scanner window

8. *If it is appropriate to restore power (wait at least 5min), press the blue “power on” button located on the Siemens control box next to the control room window. The system will need approximately 15 minutes to reinitialize. To avoid subsequent problems, make sure that the bed is completely out of the gantry at its home position and that the top head coil is attached and plugged in or off the table before restoring power.*
